# SUBSURFACE VIEWS

GPR INNOVATIONS
HARDWARE AND SOFTWARE

Detecting and Identifying Water Fraud

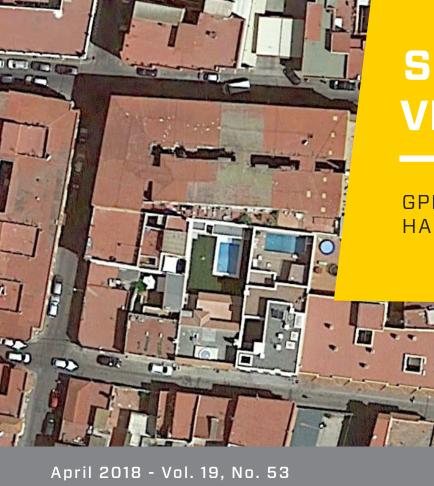
Figure 1: Illegal pipe circumvents the water meter.

While some loss to leakage does occur, in some cases fraudsters are paid by unscrupulous home or business owners to tap into water mains and bypass the water meter, resulting in low or no water bills (Figure 1).

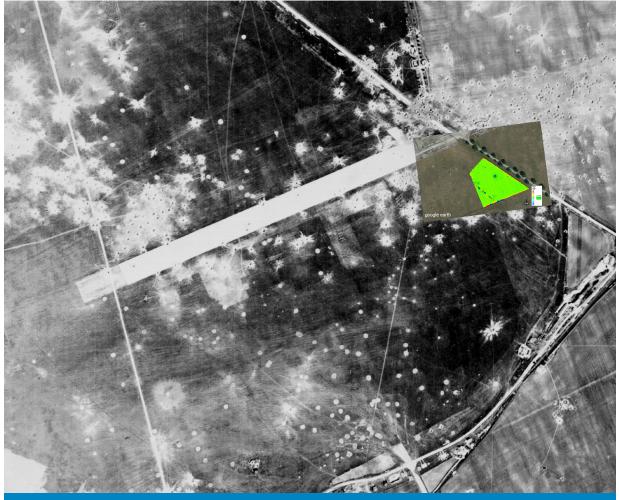
Figure 1: Aerial image of the airport in Oberschleissheim from 1945, with the UXO survey area overlaid in green.

One area that was subject to significant bombing during World War II was the airport in Oberschleissheim, north of Munich. Hundreds of bombs are still suspected to be buried in the airport compound. The company MuN Ortung GmbH was contracted to investigate a 10,000 m² area of the airfield and safely remove all UXO (Figure 1).

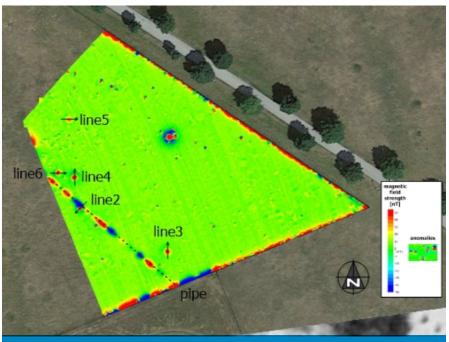
**Figure 2:** Magnetic survey results indicating point targets of interest. GPR lines (2-6) were collected over the areas of interest to confirm findings and determine depth of the target.

As a first step, they scanned the area with their 7-channel magnetometer system, towed behind a vehicle to quickly gather data over the entire survey area. Upon completion of this survey, they collected lines with their Noggin 250 MHz SmartCart GPR system over the anomalies (Figure 2) to confirm the findings and determine the depth to the targets.

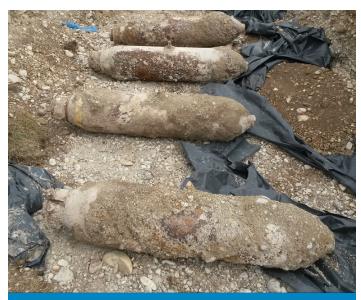
Figure 5: A total of 5 type GP 150lb T1 (General Purpose) bombs were located and safely excavated from the airport.

The UXO survey was successful, and 5 potentially deadly UXO (Figure 5) were safely located and removed thanks to the Noggin GPR system and the expertise of the MuN Ortung team. Story courtesy of MuN Ortung GmbH

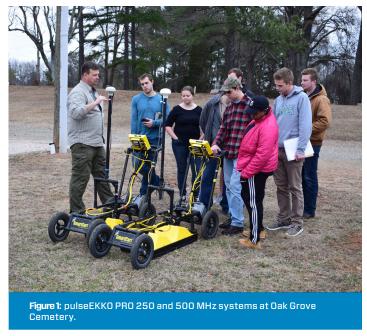
### Oak Grove Cemetery, Raleigh NC.

This semester the Environmental and Engineering Geophysics class at NCSU took on the challenge of delineating unmarked graves within portions of Raleigh's Oak Grove cemetery—using 250 and 500 MHz antennas deployed on SmartCarts (Figure 1). Data images from the GPR survey are shown in Figure 2. The data images show undisturbed stratigraphy to the left and a series of burials at variable depths to the right.
