Subsurface Views

Sensors & Software Inc.

New: EKKO_Mapper 64-bit

Airplane through Runway

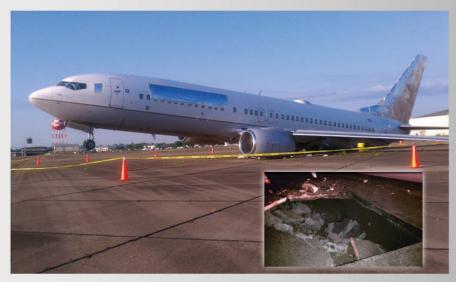
The wheels of a refurbished Boeing 737 suddenly dropped through the concrete, causing \$1.5 million damage to the aircraft. A large void (inset) was discovered underneath the taxiway.

fficials at the Mid Delta Regional Airport (former Greenville Air Force Base) in Mississippi were shocked when the wheels of a refurbished Boeing 737 suddenly dropped through the concrete taxiway. The aircraft sustained \$1.5 million in damages. A large void was discovered underneath the taxiway.

Geologists speculated that subsurface processes, associated with the flooding of the nearby Mississippi River the previous spring, caused voids to form under the concrete.

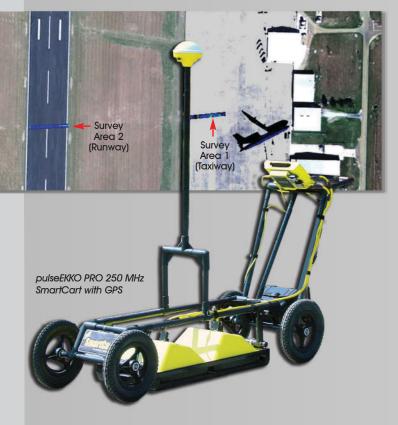
Both areas were surveyed using a pulseEKKO PRO system with 250 MHz transducers on a SmartCart configuration. Survey Area 1 was 60 x 5 meters with lines spaced every 0.5 m in both the X and Y directions for total survey line length of 1.3 km. Line A-A' on page 4 shows a cross-section over a pipe; a classic hyperbola revealing the location and depth of the pipe. The linear path of the pipe can be seen on the 95 - 100 cm depth slice of the grid data. Line B-B' shows a cross-section over a void; strong, horizontal responses from the void on the left mask one side of the hyperbolic response from the pipe. The areal extent of the void is revealed in the 40 - 45 cm depth slice; the void's high amplitude responses are plotted in red.
