CONSTRUCTION-PRACTICE CLASSIFICATIONS

Case Study

Roadmap survey

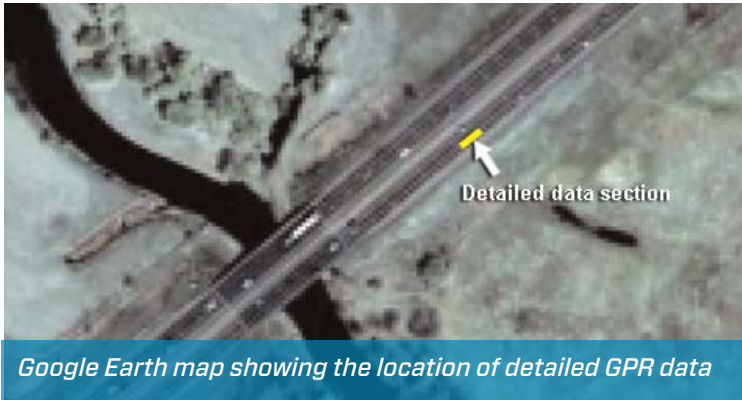
Cross-sectional data from the area, clearly show the unique character of joints in the subsurface concrete slab. The concrete slab is covered by 200 mm of asphalt.

In many instances, historic construction practice may not be known or documentation readily retrieved. RoadMap GPR creates images and tabulated data which classify changes in construction practice. The example shown here is from an investigation of a section of Hwy. 401 near Toronto, Canada clearly show the unique character of joints in the subsurface concrete slab.

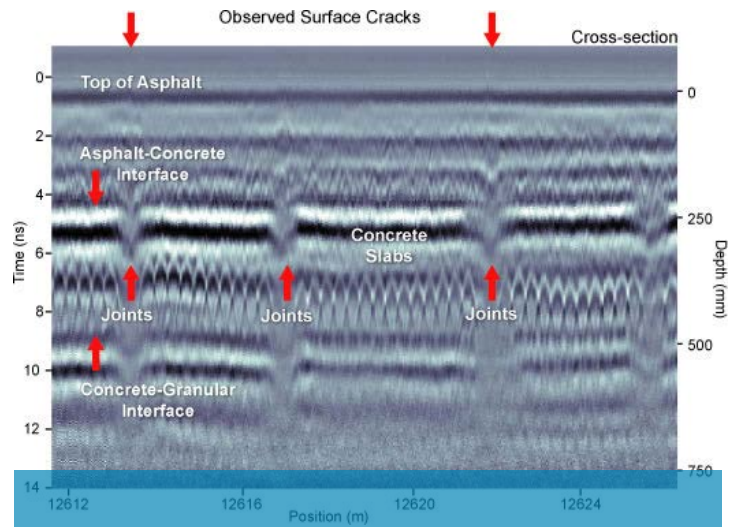
Survey data showing joints in a concrete slab covered by asphalt. Disturbance observed in asphalt above the joints indicates movement of asphalt layer has occurred above joints which lead to cracking and the potential for water inflow.

After correlating the GPR with other data, the abrupt localized changes were confirmed to be joints in the underlying concrete slab. The change in signal character is associated with fine grained material and water retained in the concrete joints.

Slight deformation of the asphalt structure above the joints suggest upward migration of the deformation. These characteristics are clear indicators of slab movement at the joints.

The next example of GPR image shows a short section of the road. This character was observed over several kilometers indicating the uniform road construction practice.
